WROUGHT IRON *for* UNDERGROUND SERVICES

A TECHNICAL BULLETIN PREPARED BY THE ENGINEERING SERVICE DEPARTMENT

A. M. BYERS COMPANY • PITTSBURGH, PA.

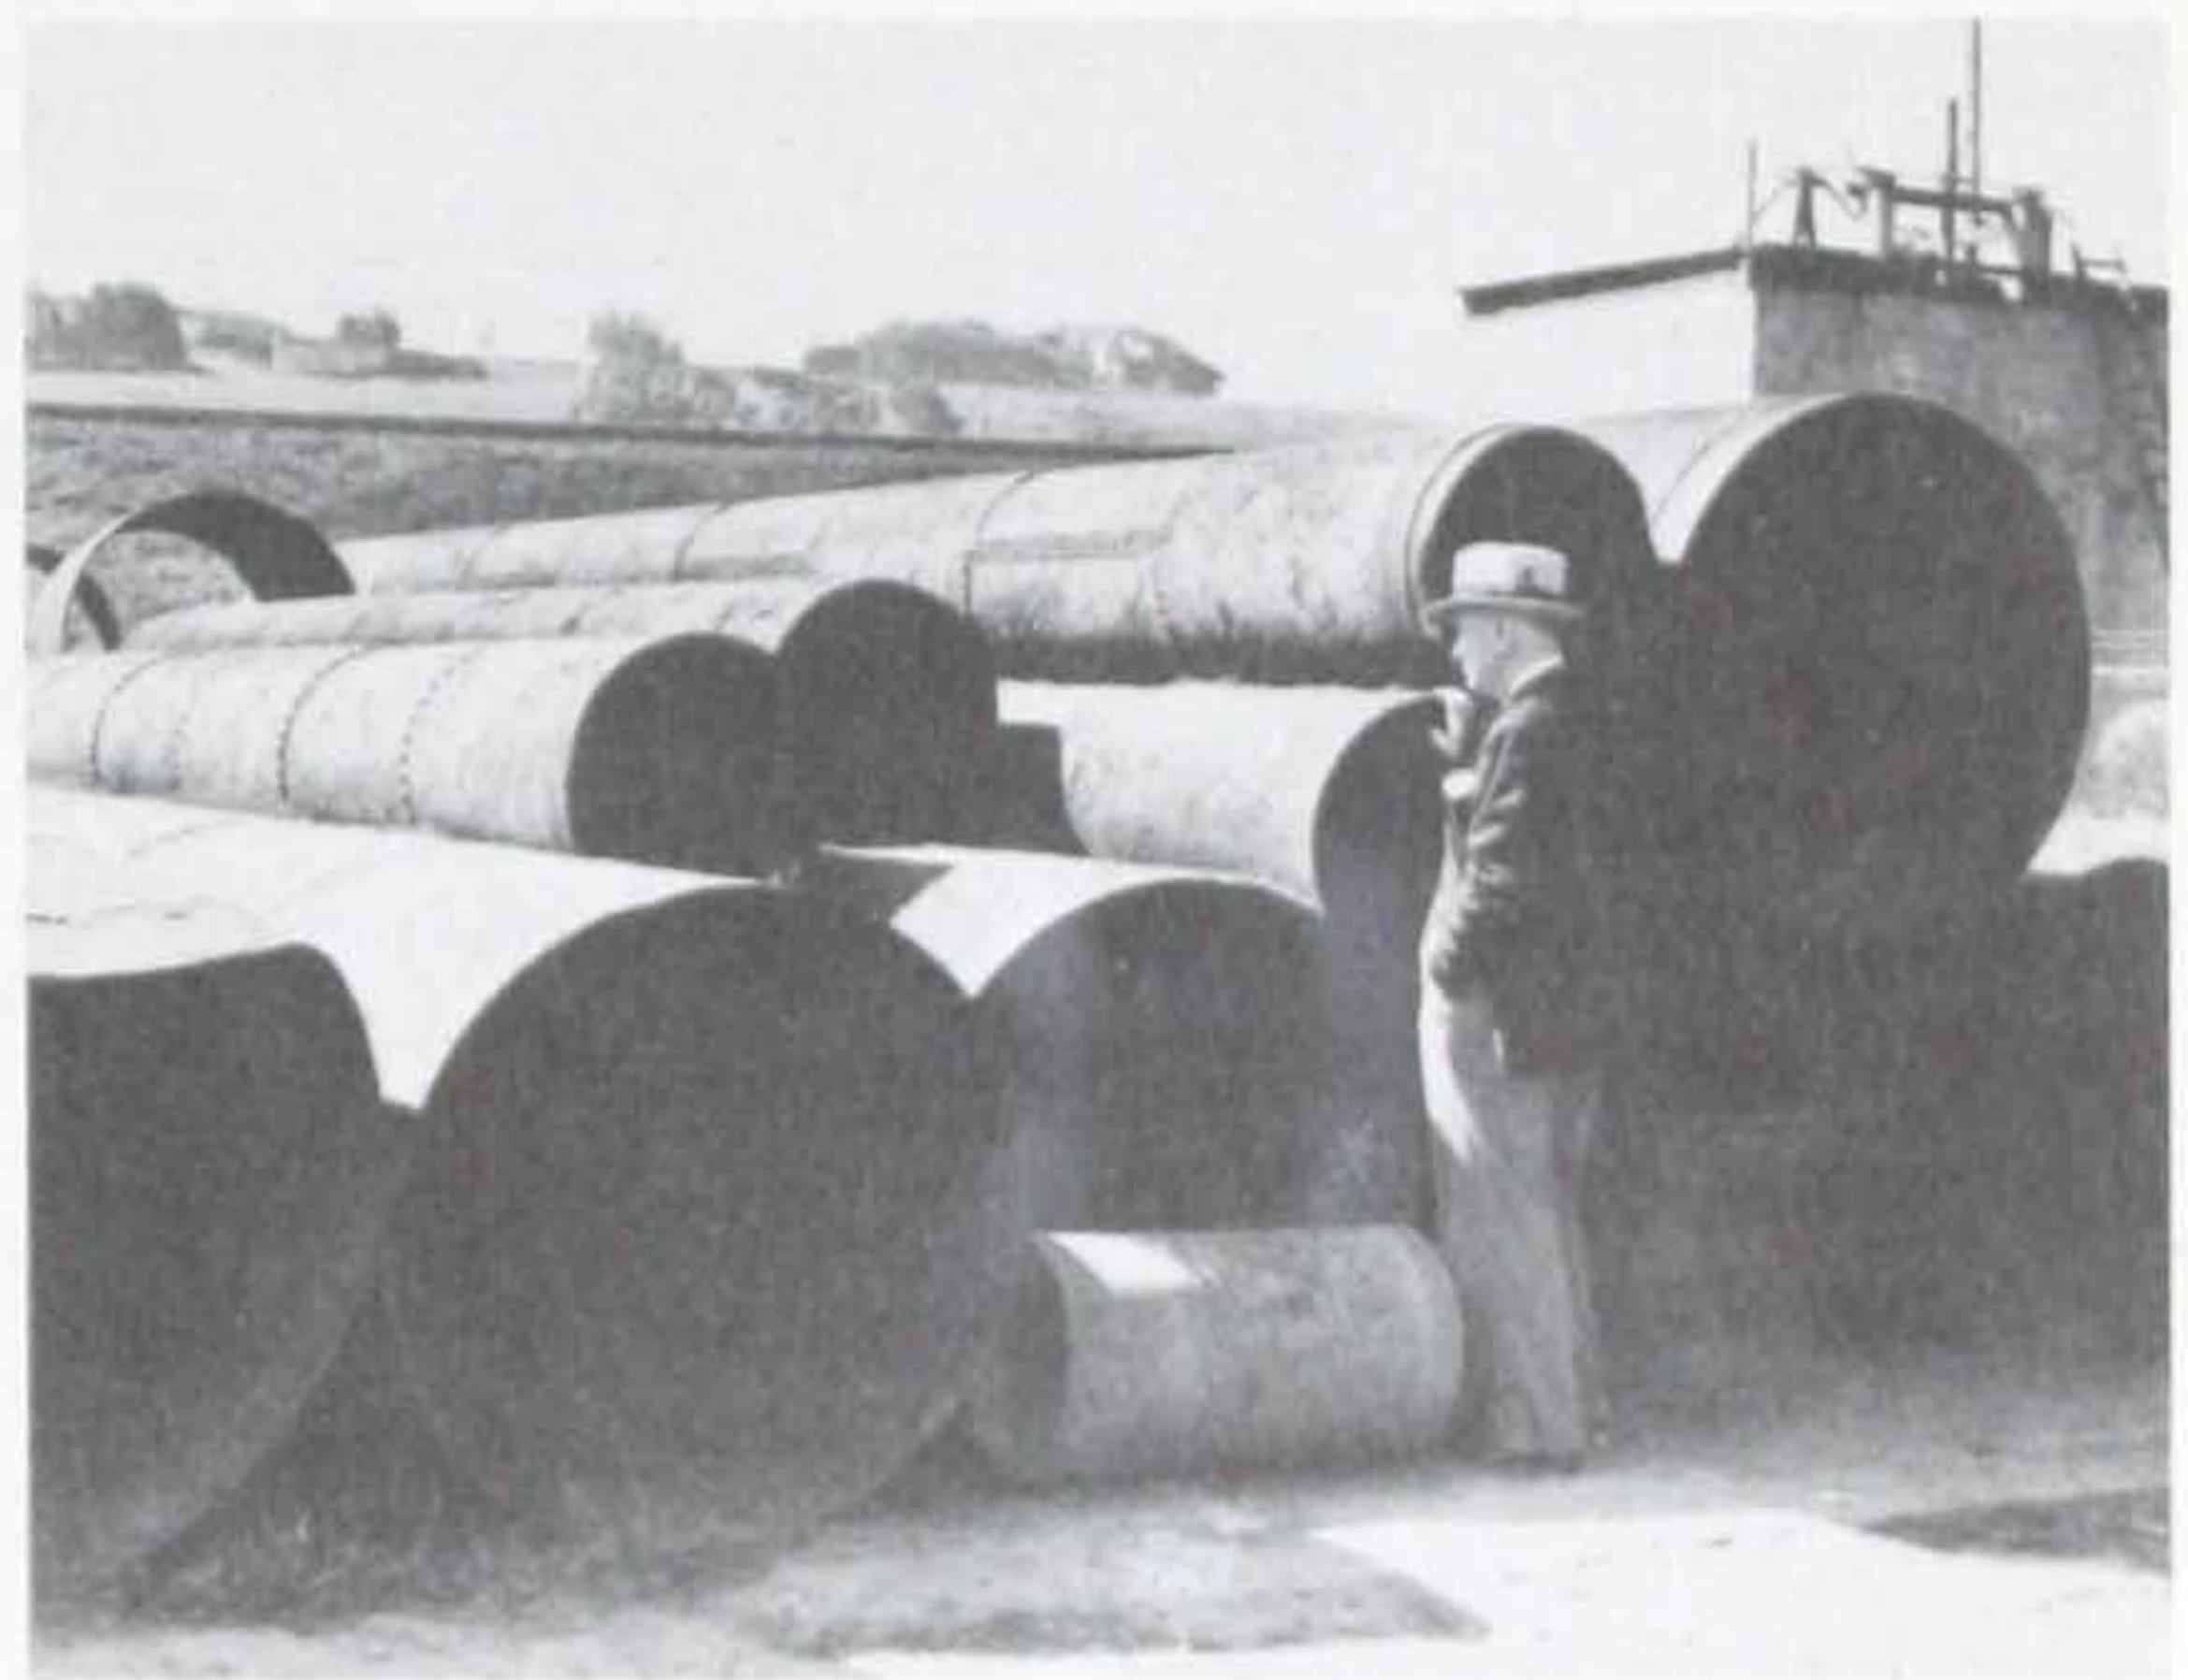
Fig. 3

The pipe used to replace the 54 year old material was also wrought iron that had served between 30 and 40 years before removal for cleaning. Part of it is shown in Figure 3.

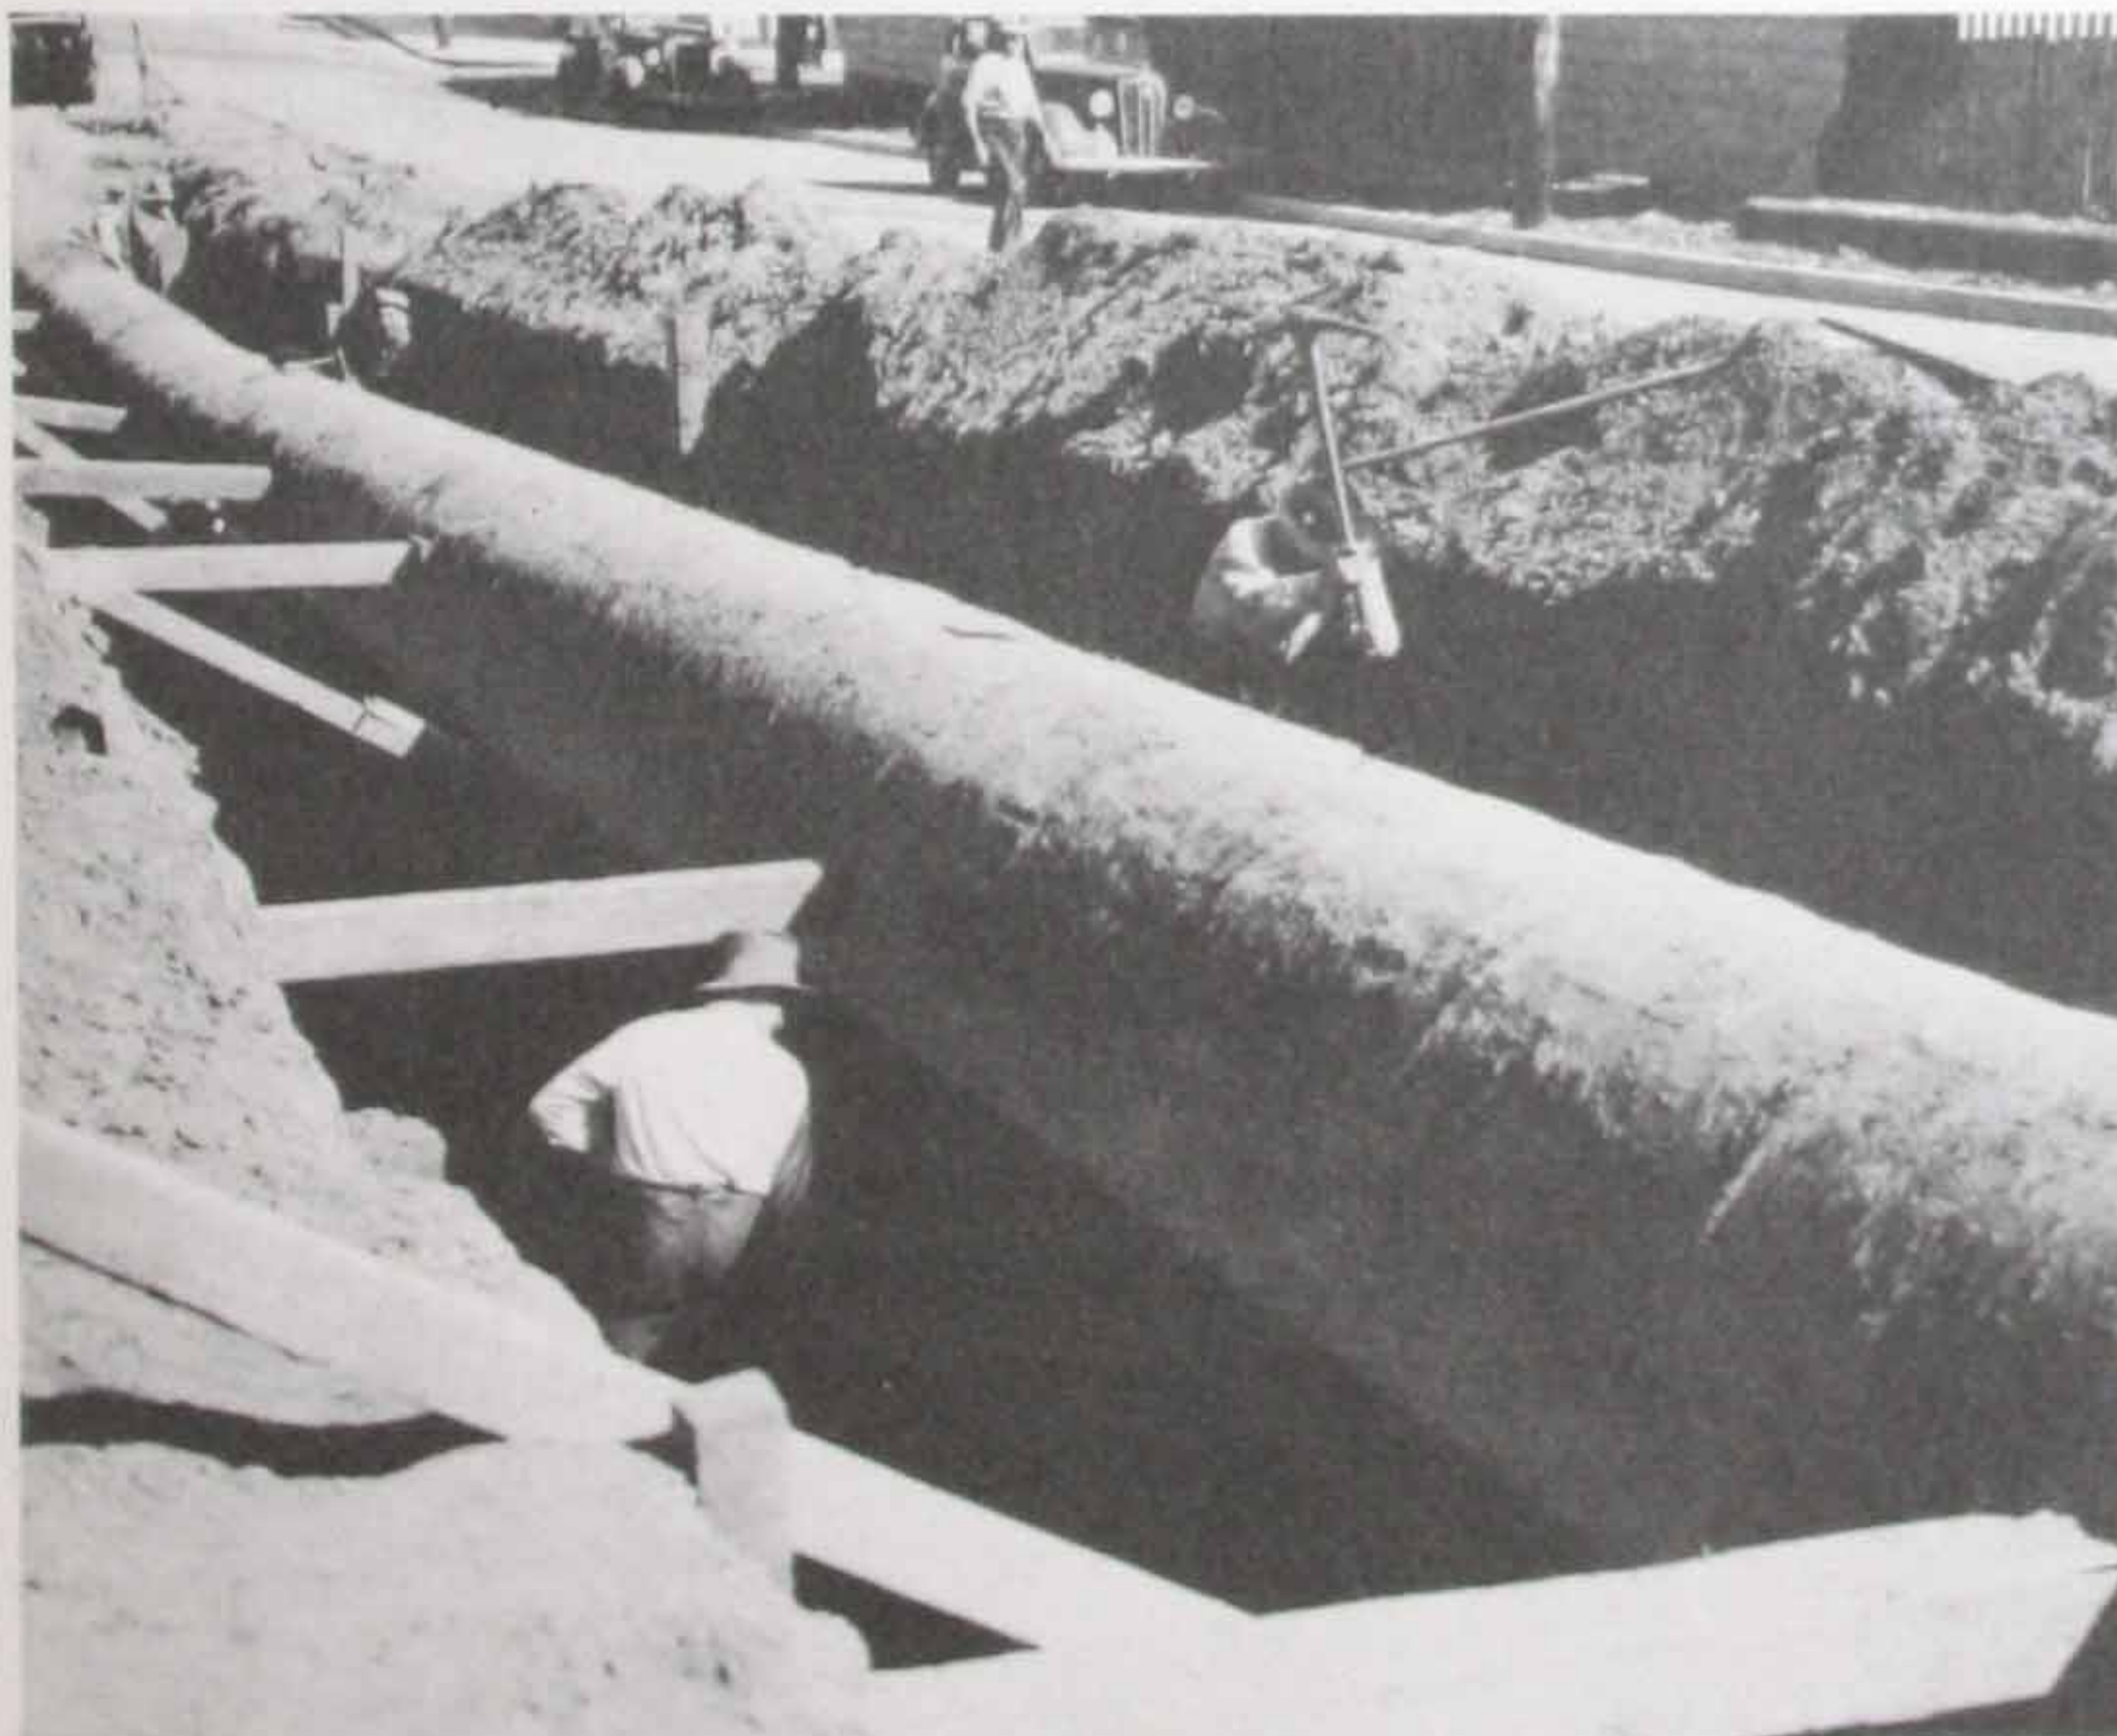
Fig. 2

For example, in Figure 2 workmen are shown removing a 200 ft. section of 44" O.D. $\frac{1}{4}$ " wall genuine wrought iron pipe. It had been in continuous service for 54 years and no holes or thin spots could be found in it. Accordingly it was cleaned and placed in stock for making replacements or extensions.

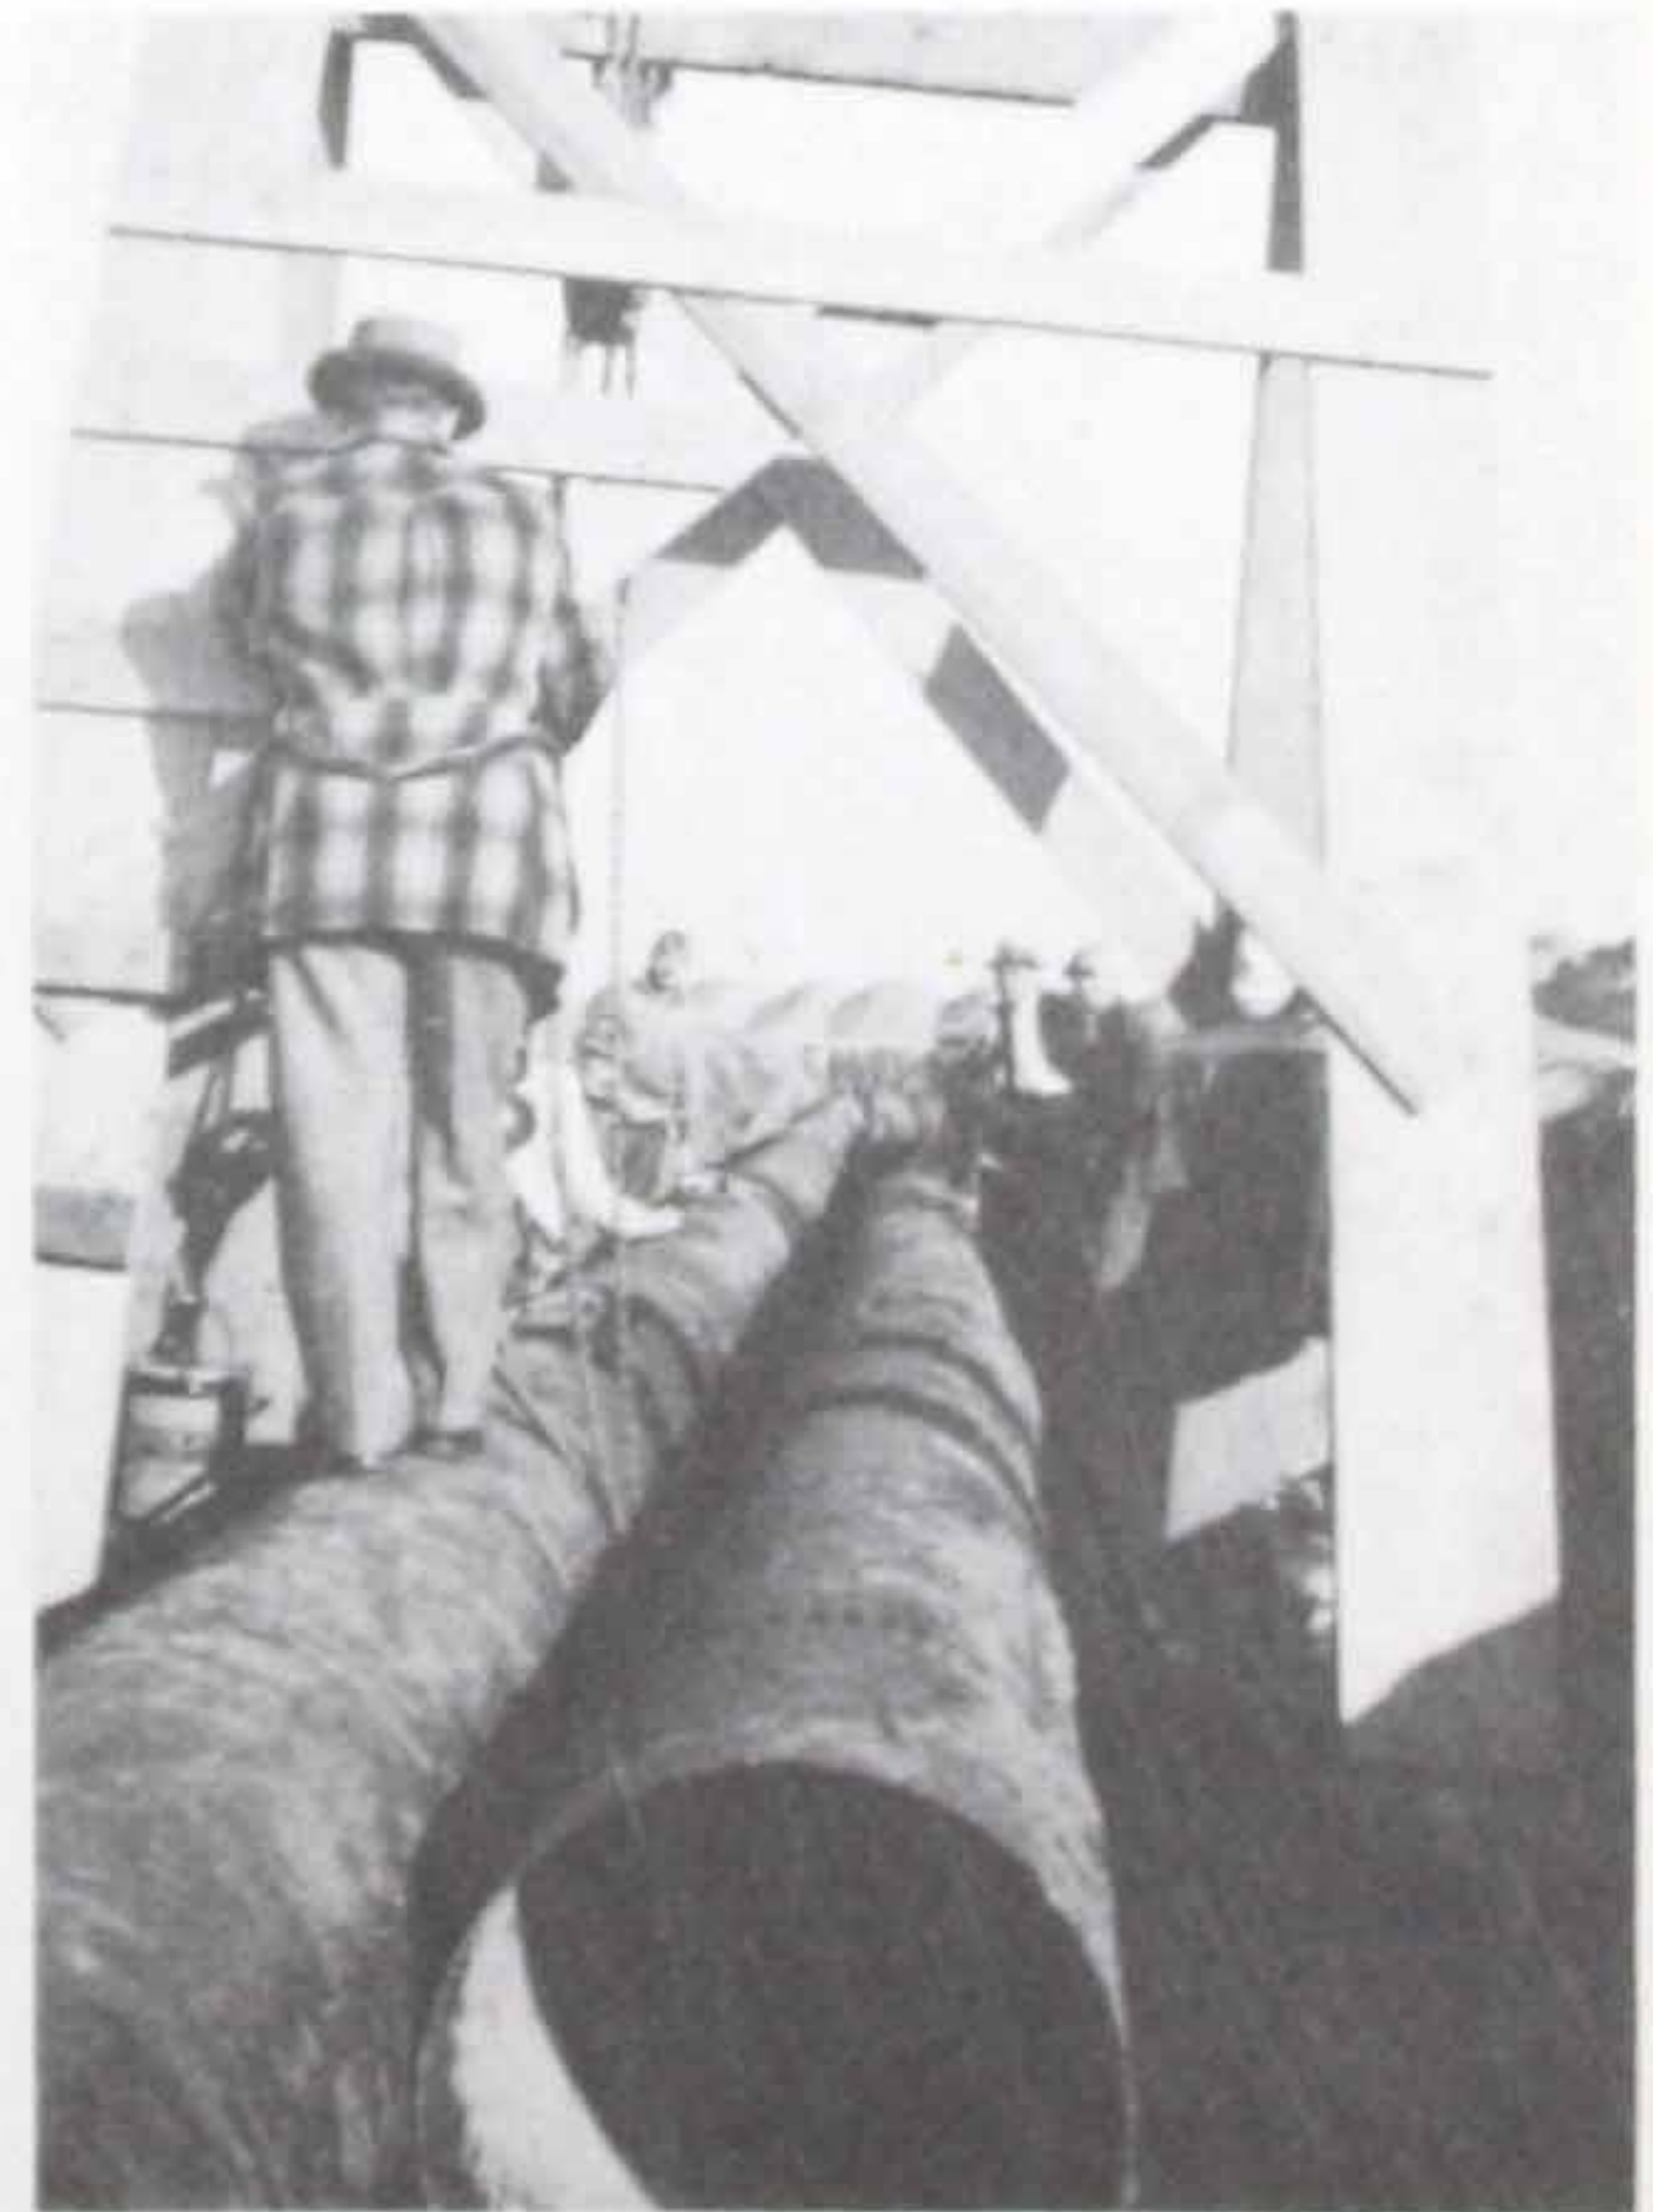
Fig. 4

Another old line was recently moved to make way for the Metropolitan Life Insurance Company Building Program on the Inglewood Golf Course in West San Francisco. About 1340 ft. of 22" pipe with $\frac{1}{8}$ " wall thickness, and 5430 ft. of 23" — $\frac{3}{16}$ " wall wrought iron pipe were removed. Figure 4 shows the work in progress.

During the 1906 earthquake, San Francisco's only water supply was obtained through this pipe, from Lake Merced. When removed, every foot of the old pipe was examined and found to be in excellent condition.

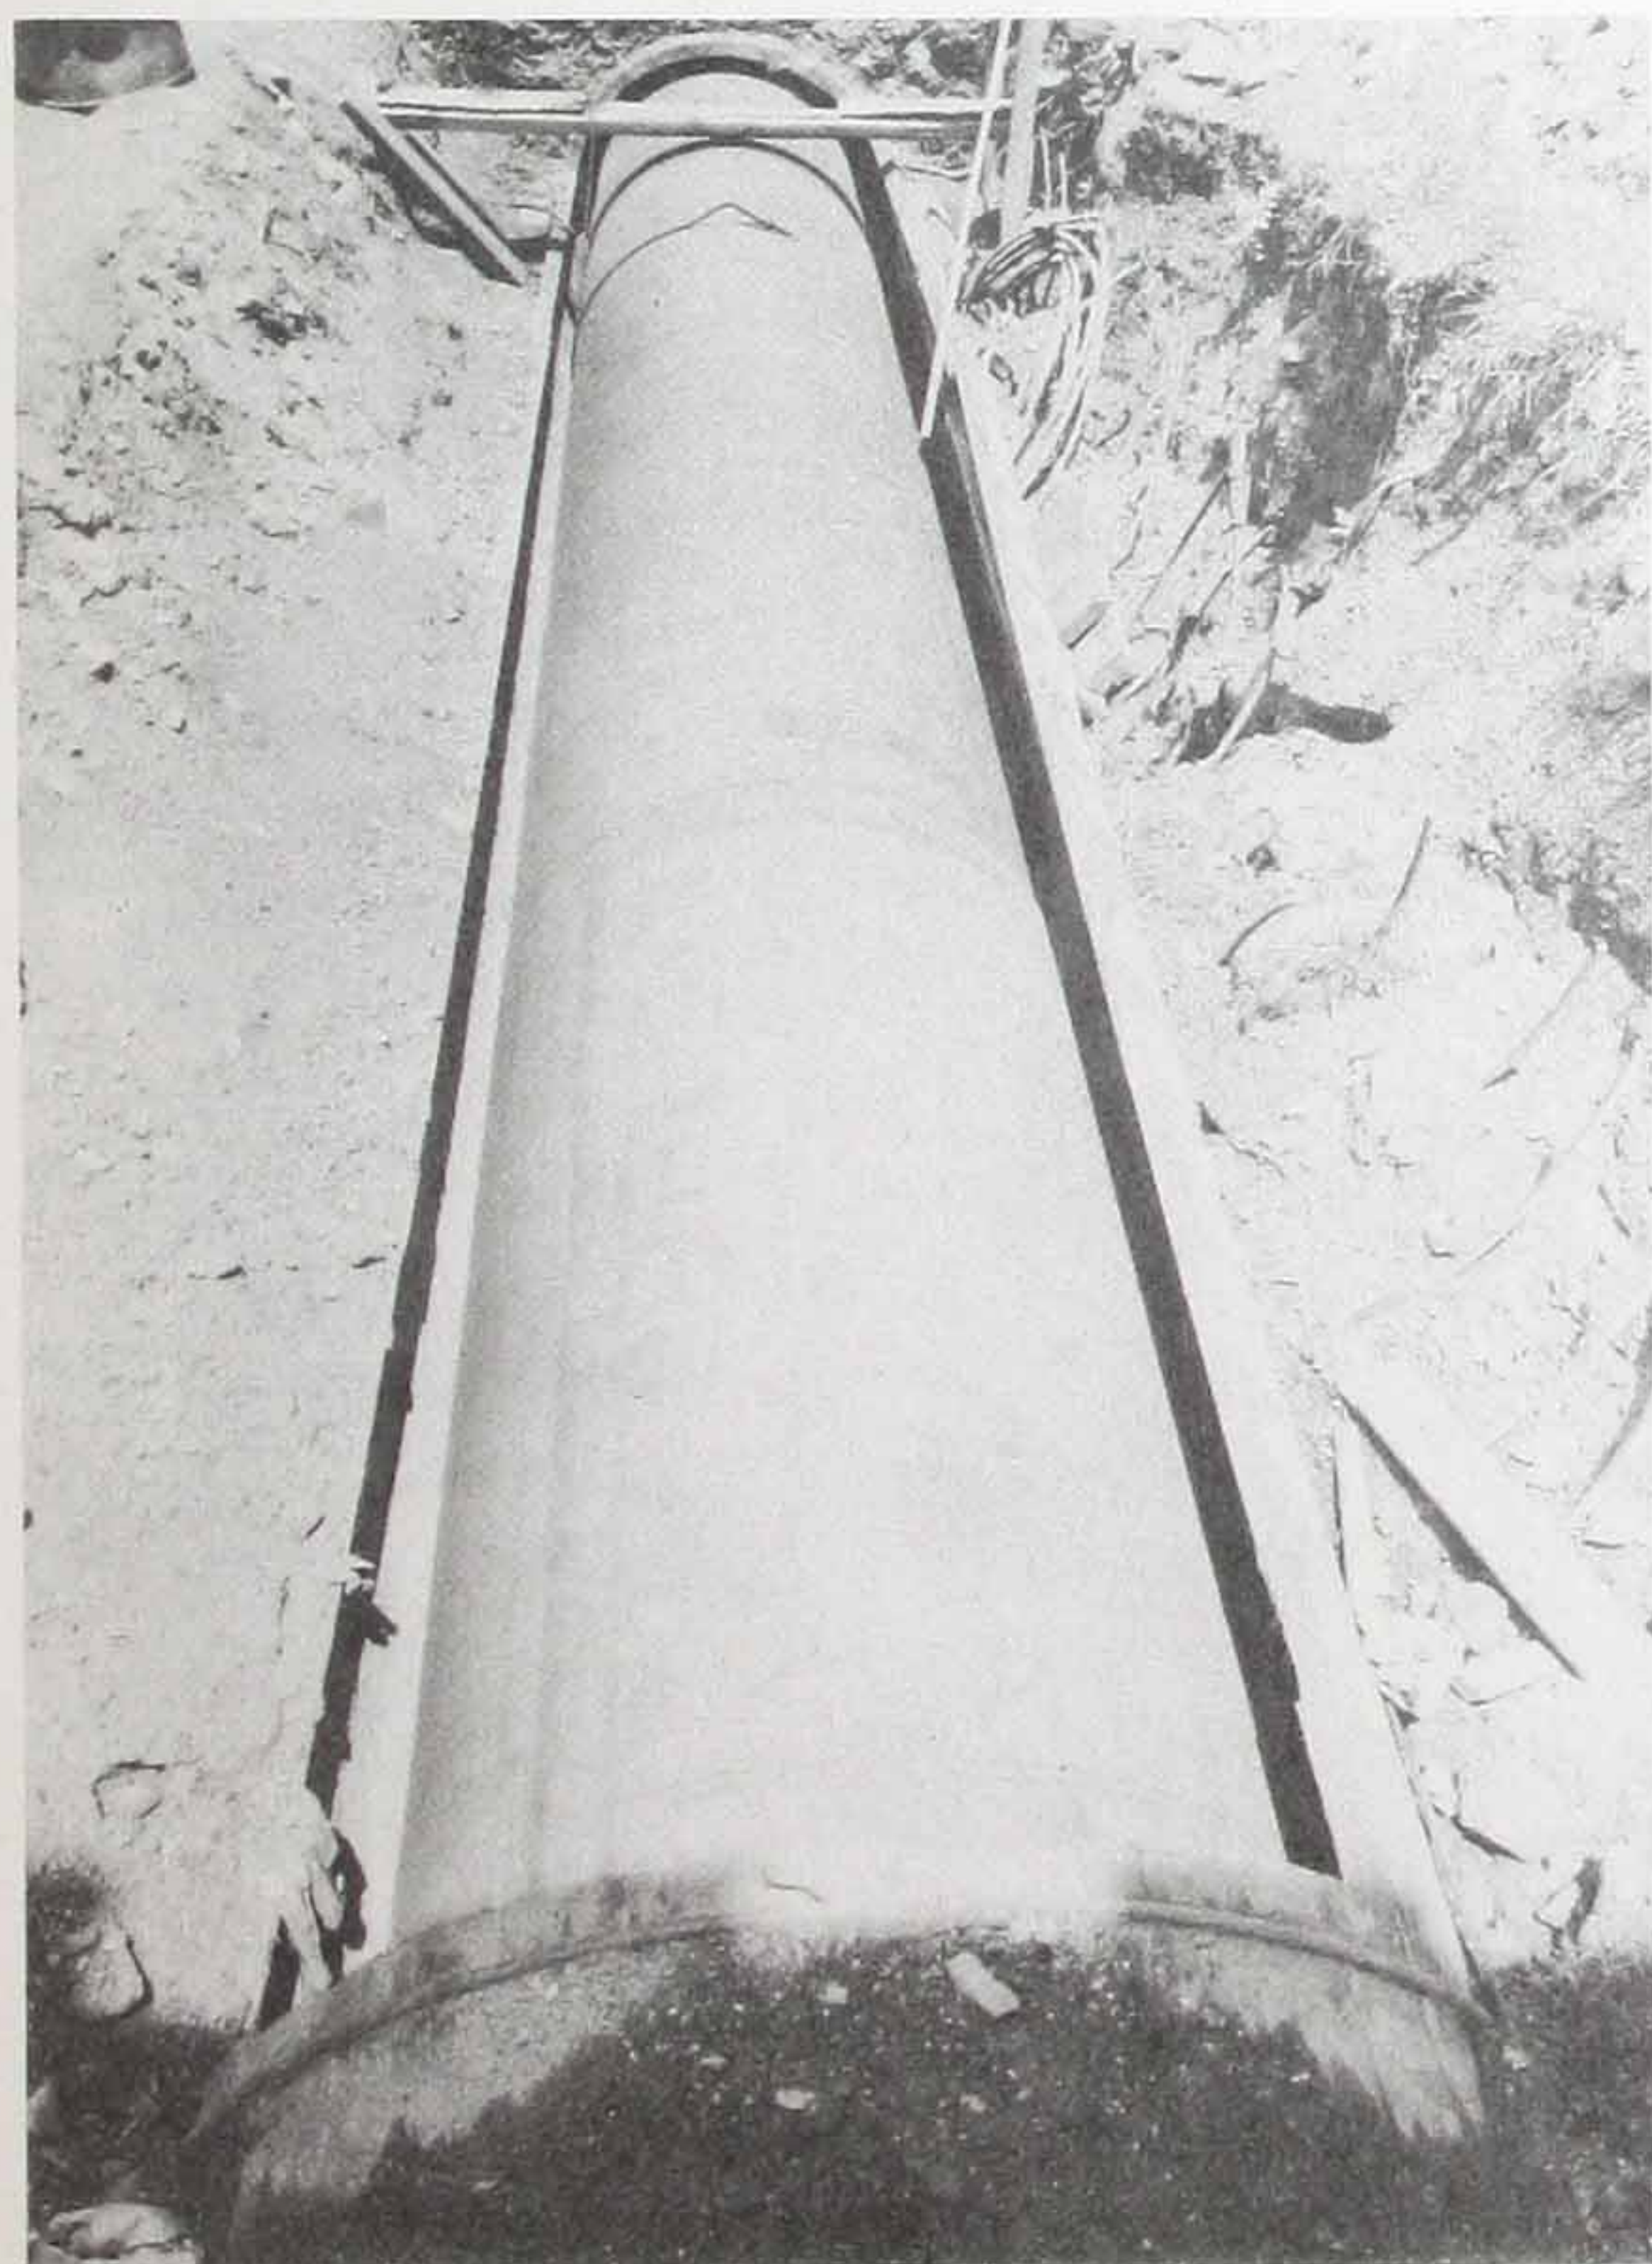
Fig. 8

Figure 8 shows a new wrought iron penstock over 200 feet long and 52" in diameter being installed at the American Felt Company's plant in Glenville, Connecticut. Five-sixteenth inch plates were used by Walsh Holyoke Steam Boiler Company of Holyoke, Massachusetts, in fabricating this pipe and, as can be seen in the photograph, the pipe is laid inside the old wooden penstock which was being replaced. Due to seepage of ground moisture through the old penstock, and the possibility of tannic acid being leached from the wood, highly corrosive conditions can be expected and for this reason, wrought iron was selected.

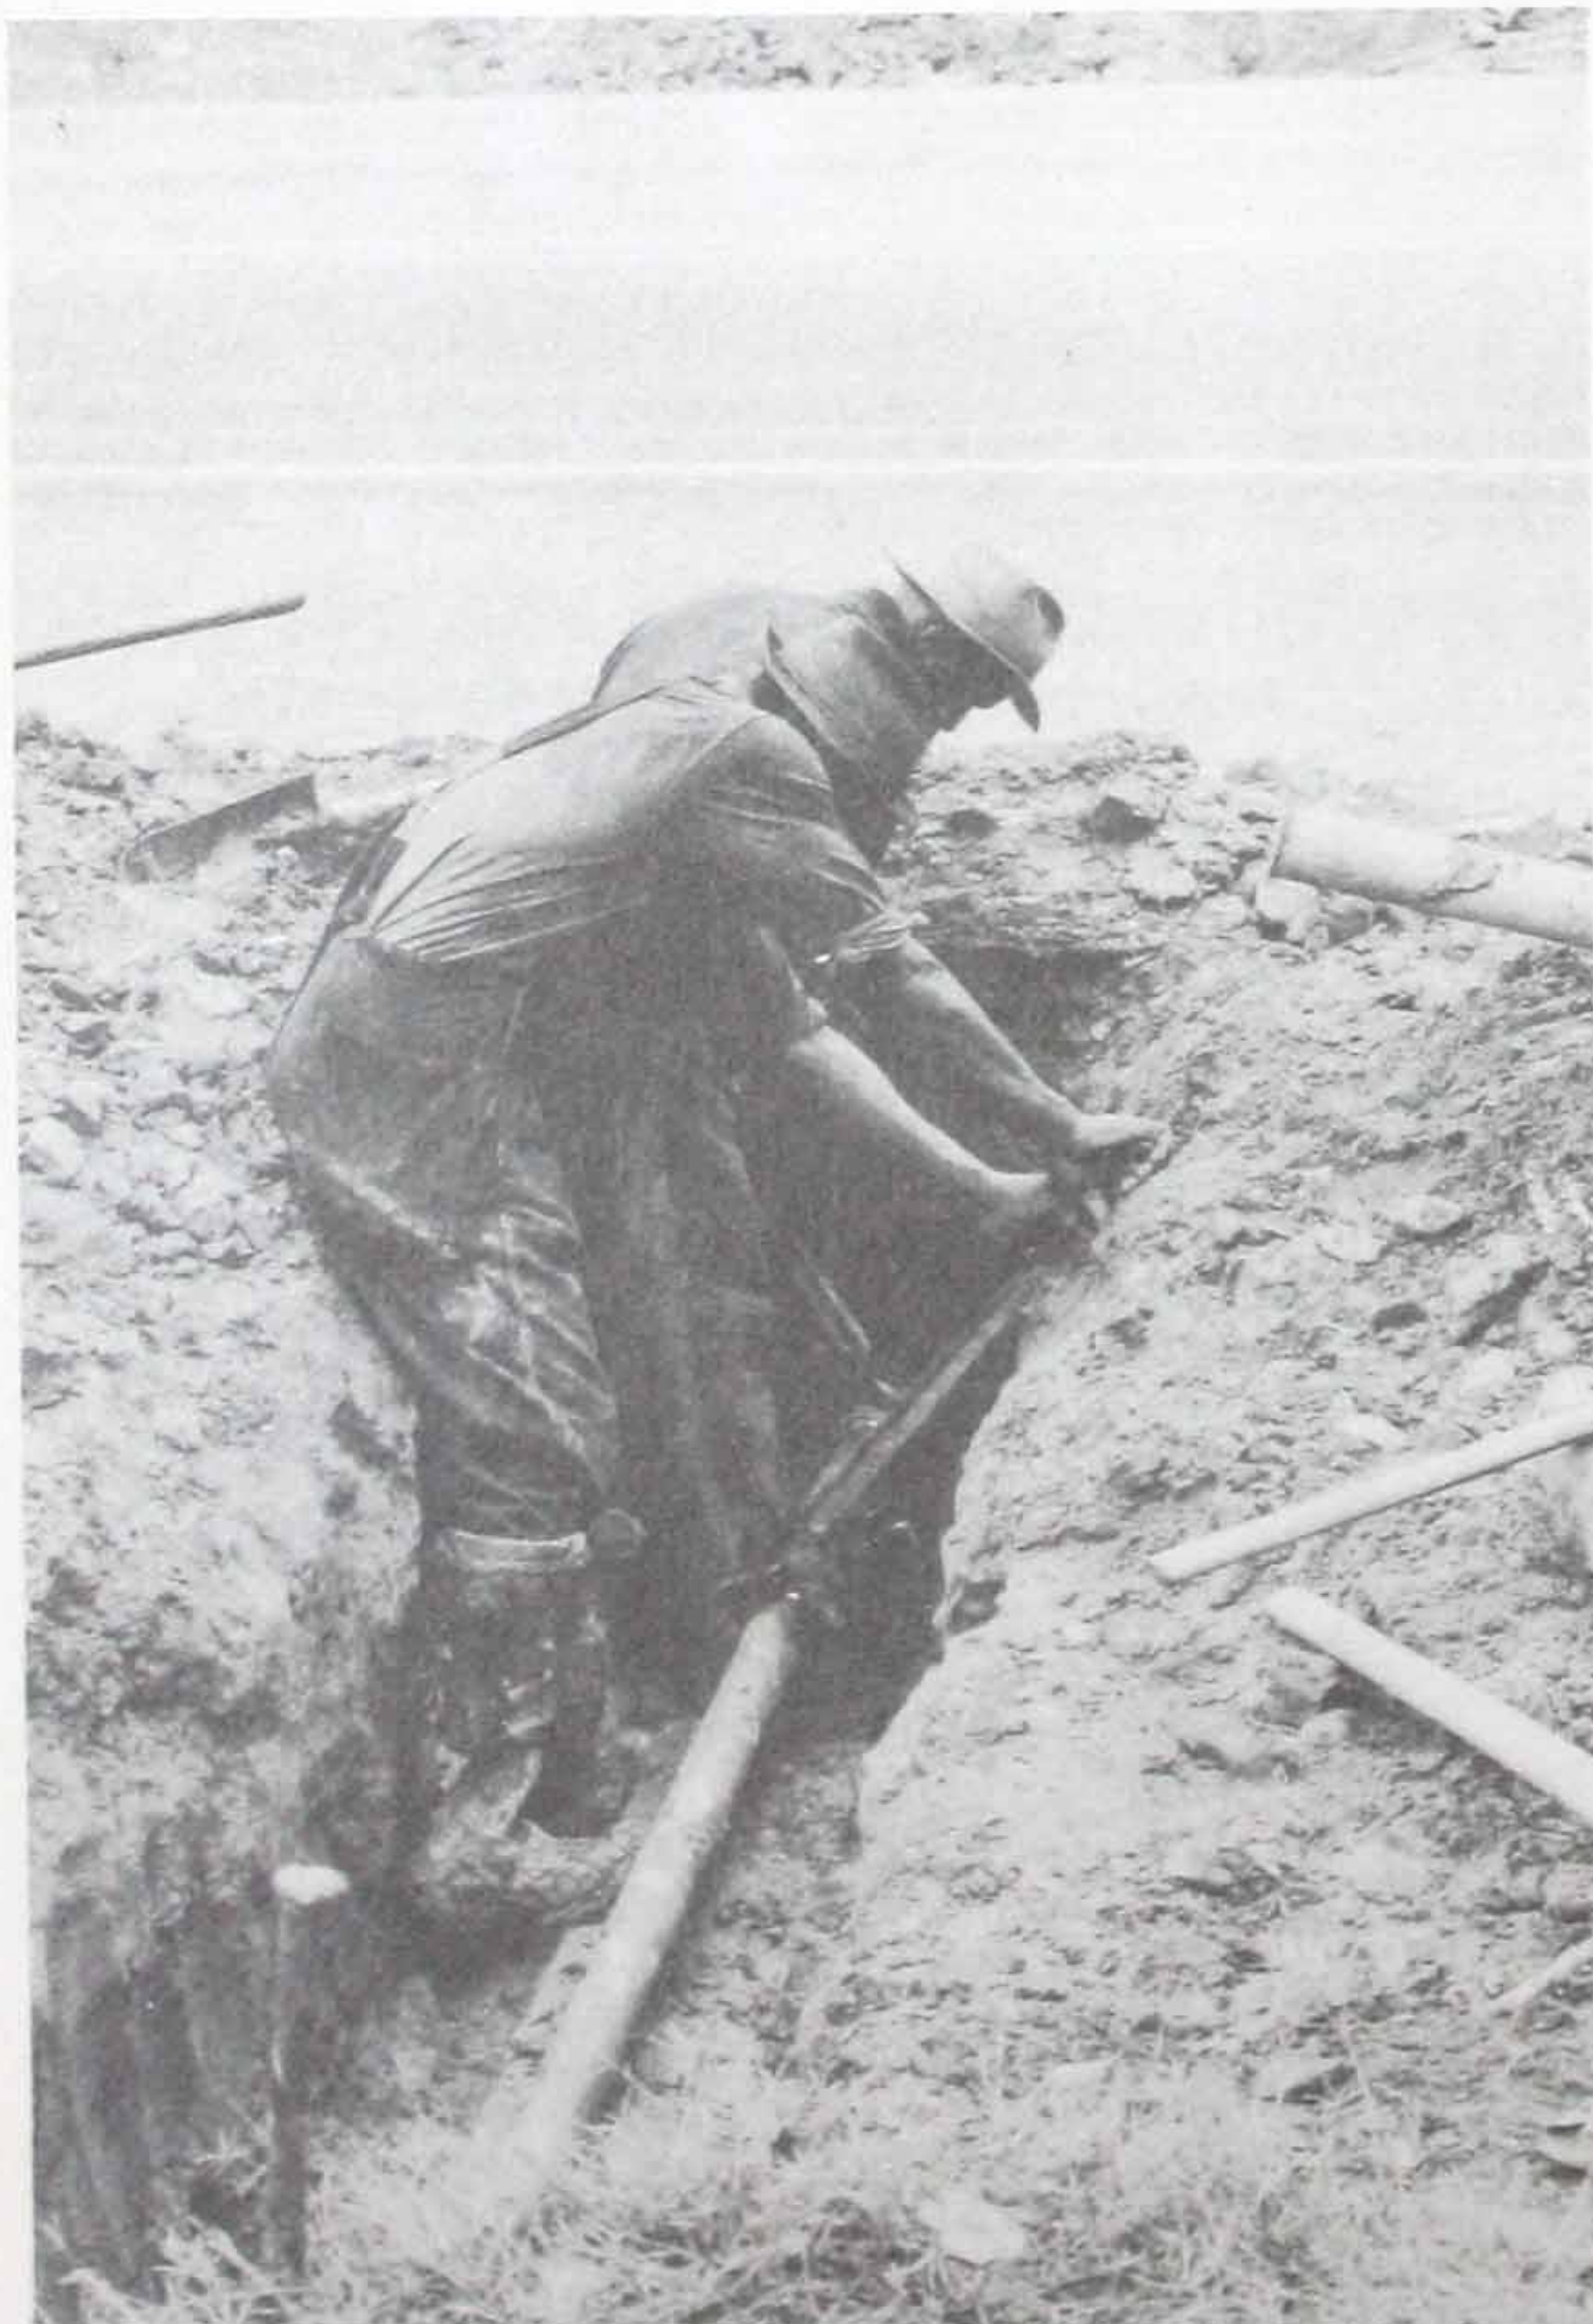
Fig. 10

We have been informed by the Superintendent of Water Supply of the City of Charlotte, North Carolina, that wrought iron is the only material in use there for water service lines $\frac{1}{2}$ " to 3" in diameter. Figure 10 shows a new $2\frac{1}{2}$ " galvanized wrought iron service line being installed to serve a land development along Wilkenson Boulevard. The pipe was jacked under the four-lane roadway.

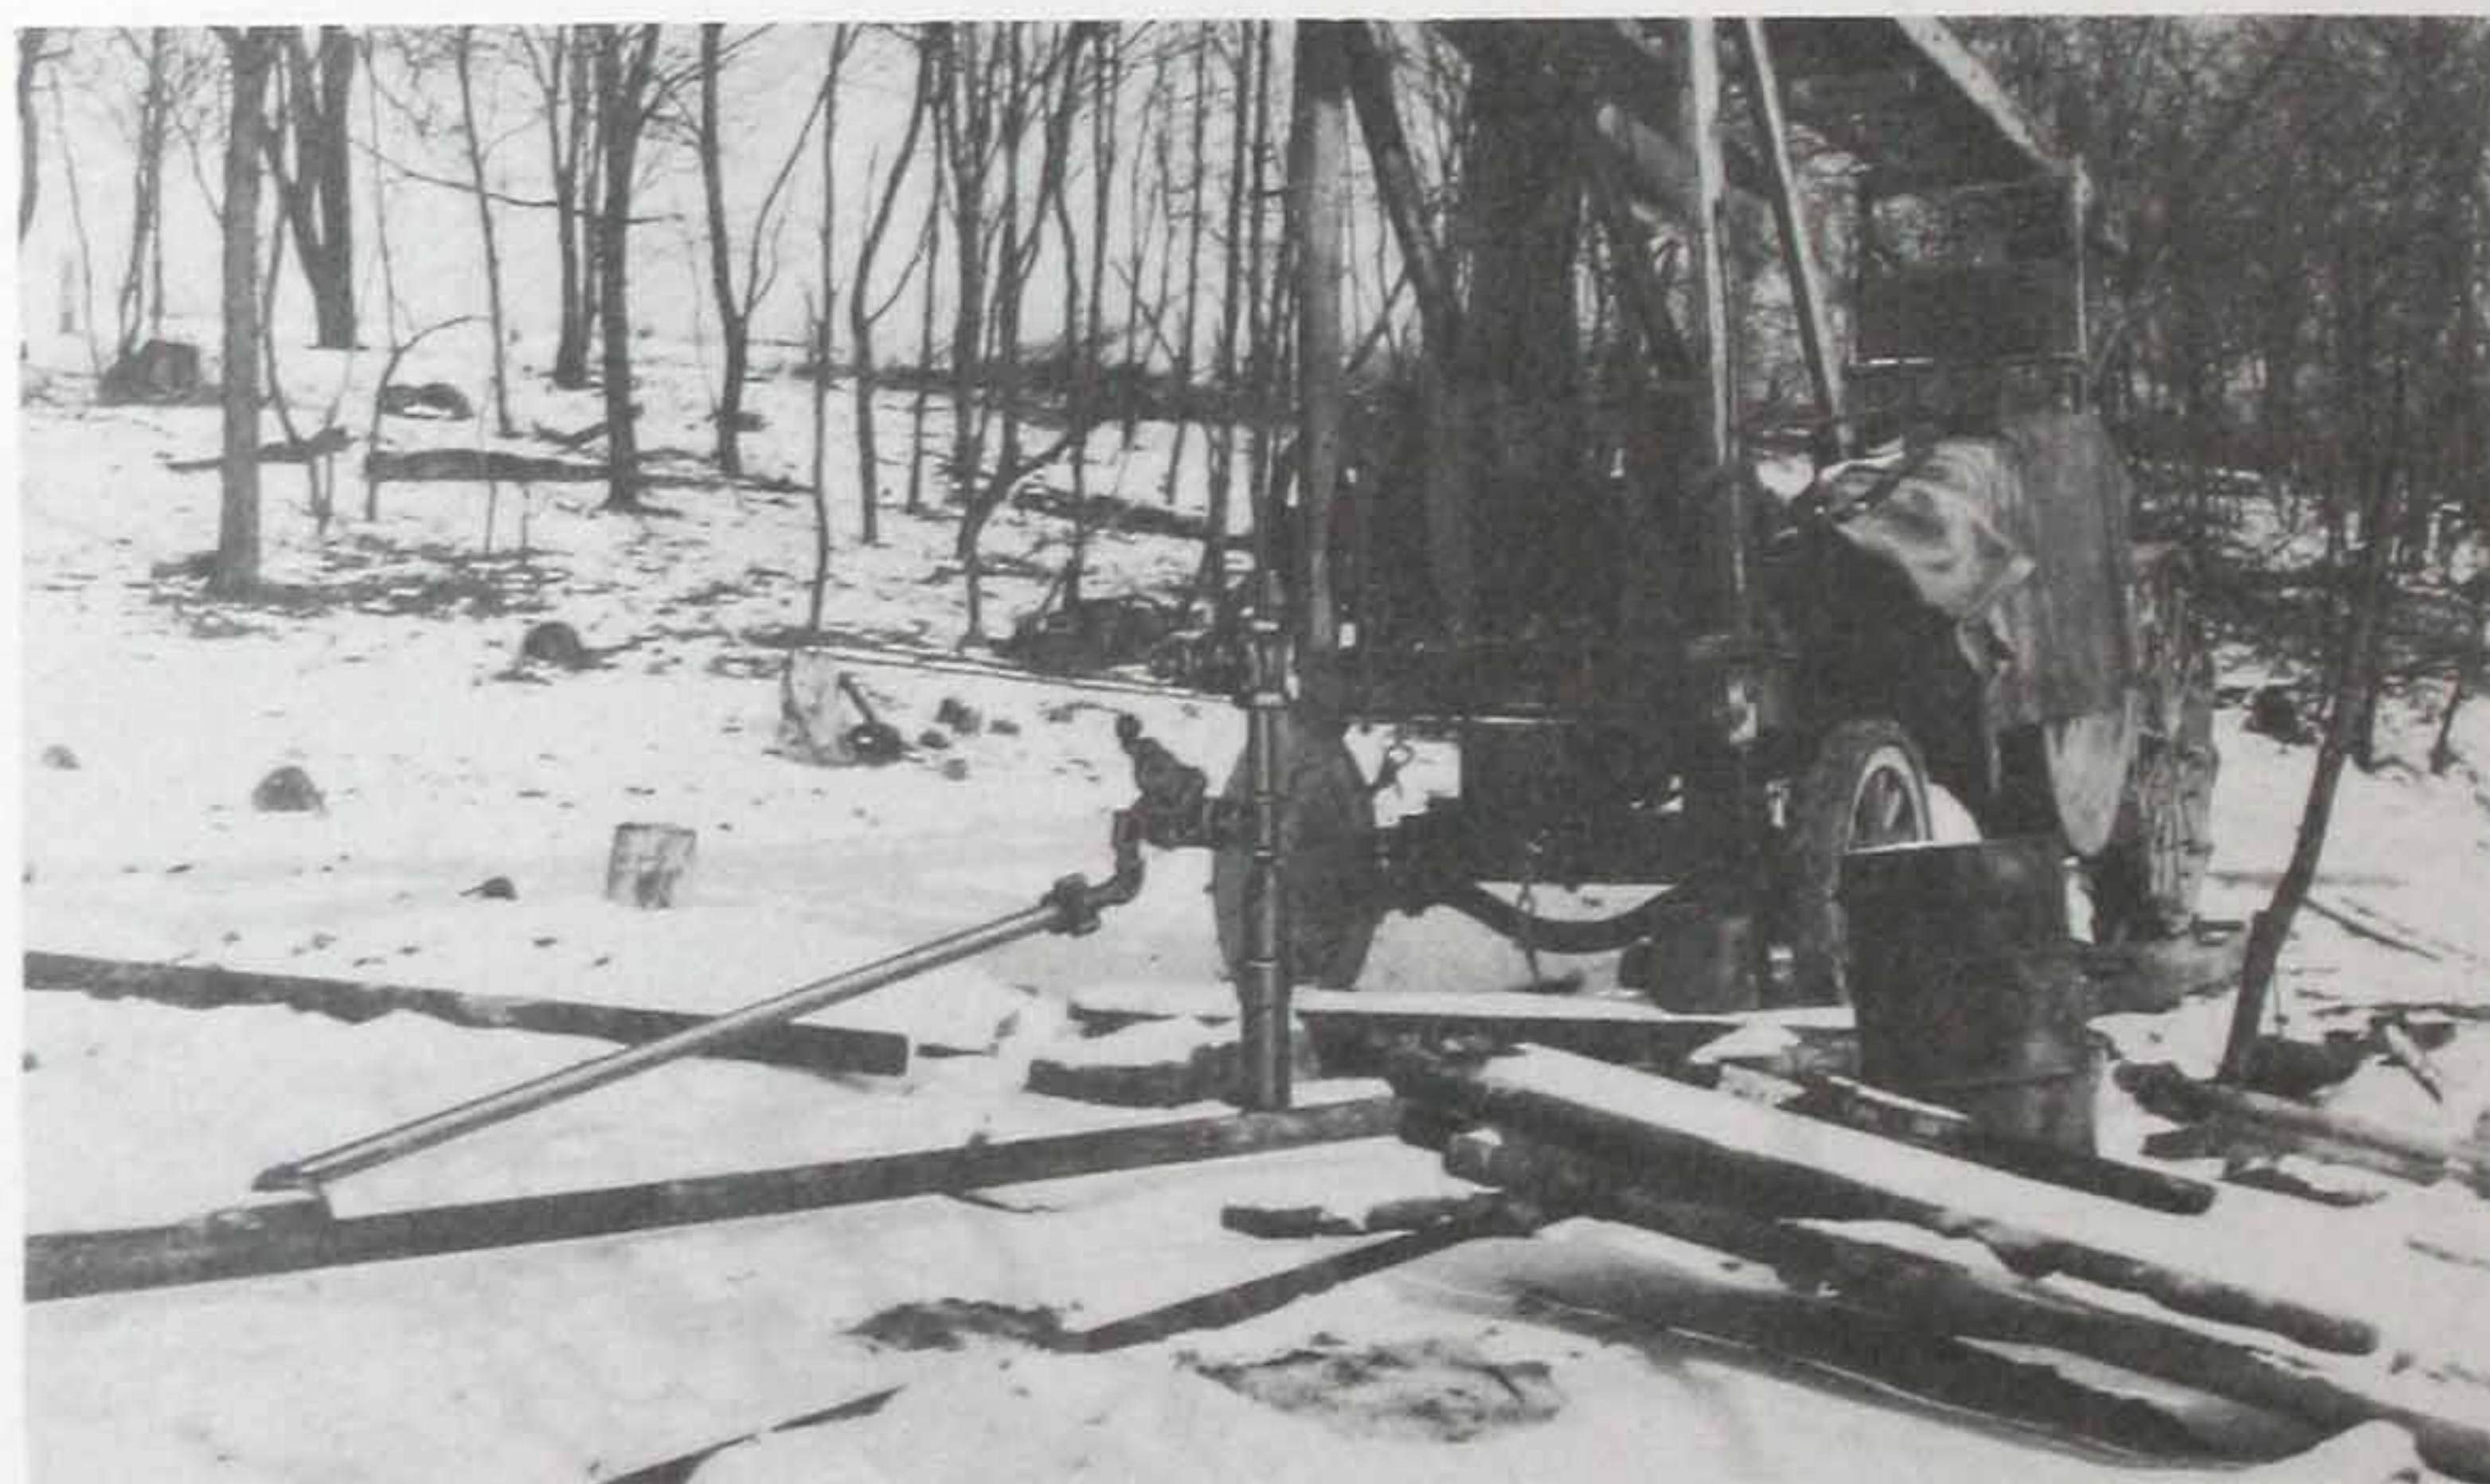
Fig. 26

The well shown in Fig. 26, was drilled near Chicora, Pennsylvania, at the time of the first "oil excitement" in that territory.
